RADOSŁAW KARASIEWICZ-SZCZYPIORSKI, OLEG Â. SAVELĀ

EXCAVATIONS IN BALAKLAVA (SEVASTOPOL, UKRAINE) – SEASON 2011. DISCOVERY OF FORTIFICATIONS OF A ROMAN FORT

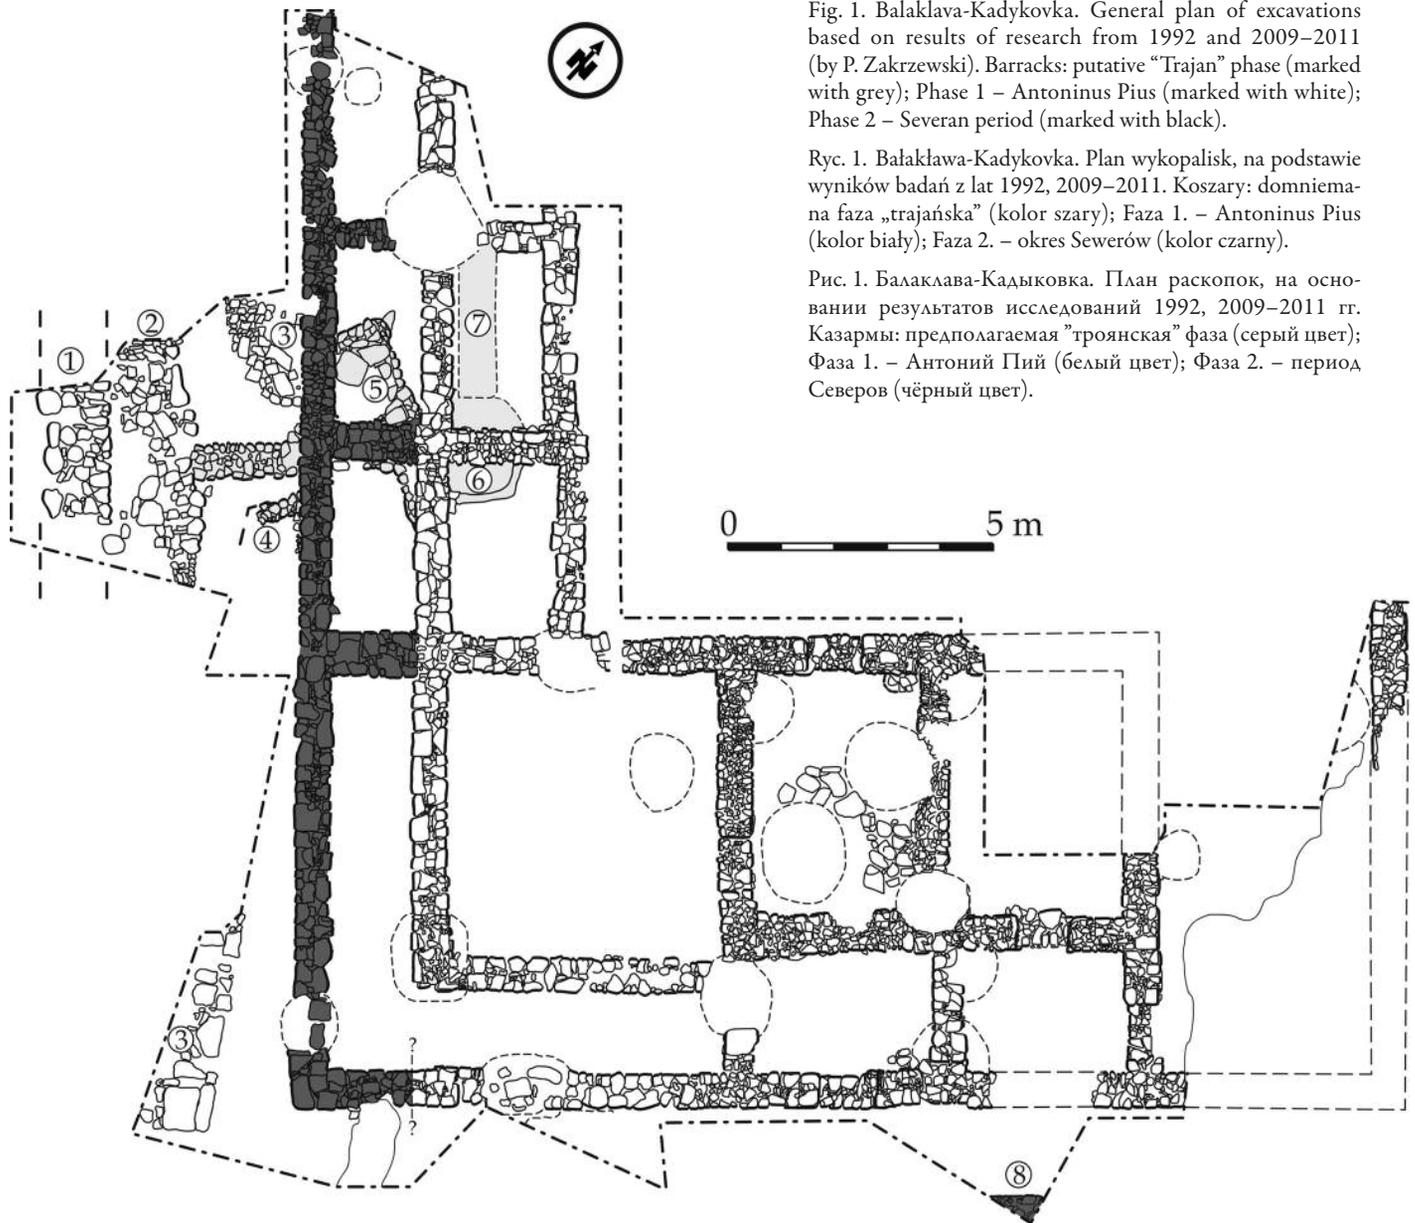
Fig. 1. Balaklava-Kadykovka. General plan of excavations based on results of research from 1992 and 2009–2011 (by P. Zakrzewski). Barracks: putative “Trajan” phase (marked with grey); Phase 1 – Antoninus Pius (marked with white); Phase 2 – Severan period (marked with black).

A majority of architectural remains which were exposed in the course of three seasons of examinations were rooms considered as part of the barrack (Fig. 1). The extension of the trench to the north revealed other rows of rooms which were a continuation of the same building. On the west, an exterior wall was exposed, analogously to an earlier case when such a wall was found on the south. Farther to the west, no traces of the portico were found. However, in some places traces of hardening of utility surface with a pavement of small pebbles and individual stone slabs (Fig. 1:3).

directions than the later premise which was referred to as the barracks (Fig. 1:5), or that these are situated lower than the floors in the barracks. Among the examined remains one can mention: a water-leading canal which was tightened with lime mortar with additive of ceramic aggregate (Figs. 1:7, 3); remains of an oval tank reservoir which was tightened with similar mortar and to which the aforementioned canal almost certainly led (Figs. 1:6, 4); a sewage canal made of small pebbles, which was tightened inside with white-yellow lime mortar (Figs. 1:4, 5). The canal is situated slightly farther to the west and slightly lower, taking into consideration the surface of the original inclination of the terrain. The preserved part of the canal is situated under the paved surface outside the barrack building (to the west).

Farther off to the west, it was possible to expose stone bases of two constructions (of walls?) in the trial trench. Both structures adjoin each other and they go in parallel to the nearby wall of the barracks. The constructions were made of almost unworked large lumps of local stone (Fig. 1:1,2). Building material was laid with no foundations, only on a substruction of small pebbles with lime mortar.

stone lumps on the substruction with lime mortar can be divided into two separate constructions. Slightly farther off from the barracks, there are regular bases made of stone lumps which are laid in such a manner that one can identify remains of the outer and inner face (**Fig. 1:1**). On the east, i.e., on the side of the barracks there is a sort of thickening of the previous building. This thickening has one facing only (**Fig. 1:2**), which indicates that it was joint to the already extant previous construction.

Examinations in the preceding seasons allowed for an identification of the building (previously referred to as “A”) as the barracks of the Roman garrison which stationed in Balaklava. The latest possible date of origin of the building is marked by the roofing tiles with the “VEMI” stamps. The parallel course of the remains of the barracks and the fortifications points out that also the revealed fortifications of the fort were constructed in the period of rule of Antoninus Pius at the latest. The fortifications consisted of the moat and the wall, which was built with no foundations. The thickness of the wall (1.3–1.4 m) and the applied method of construction are almost identical as in the case of relics of a Roman fortlet on the nearby Kazatskaya Hill. These remains come from the same period (SARNOWSKI, SABELJA, KARASIEWICZ-SZCZYPIORSKI 2003; 2007). Based on this analogy, one can explain the function of the aforementioned thickening of the fortifications from inside. Most probably, these are remains of a ramp leading to the walls (*ascensus*). This may suggest that a turret or fortifications of one of the gates of the fort were located in the neighbourhood. The space between the remains of the defensive wall and the barracks, where traces of the pavement and the fragment of the sewage canal were found (Fig. 1:3) would be part of the street (*Via Sagularis*).

It must be underlined here that in such a case we would have to do with an exceptionally narrow perimeter street. Traces of the pavement under the first row of rooms in the building of the barracks and the way of attaching the walls of these rooms to the rest of the building (merely adjoining) testify to the fact that these rooms were built on later (Fig. 6). The extension of the barracks was made at the cost of the street. Additional rooms were created by means of building on part of the street (cf. Fig. 1).

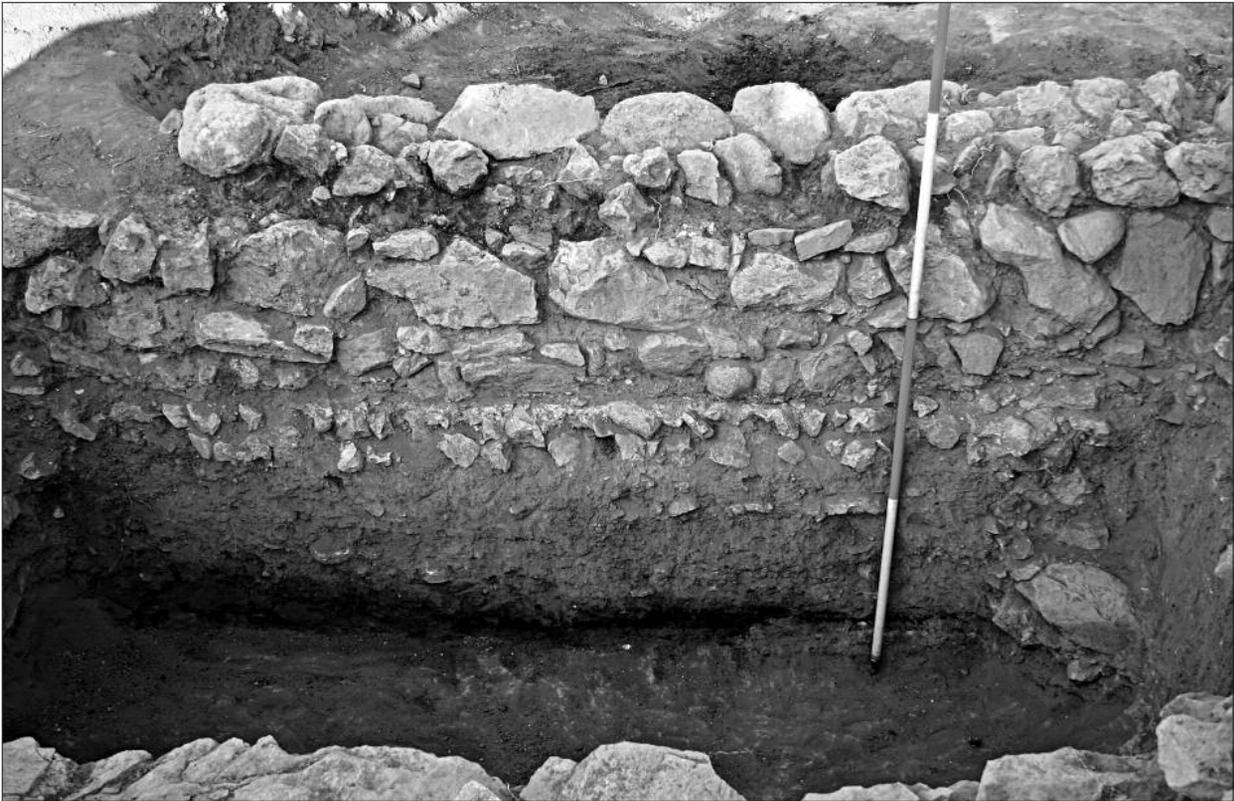
Fig. 2. Western wall of the barracks (view from the east). Foundations go on the layer of pavement of small pebbles. Layer of burning (dated to the turn of the eras) can be seen below in the section (Photo A. Trzop-Szczypiorska).

The hitherto examinations confirm that the earliest settlement phase in this part of Balaklava corresponds to the layer of burnt daub with admixture of charcoal (Fig. 2). This layer is accompanied with portable relics, which may be related to the Hellenistic Period. However, the latest finds (e.g., fibulae of Aucissa type) are to be related to the turn of the eras. In this phase there are no remains of permanent buildings, including stone architecture, within the examined area (KARASIEWICZ-SZCZYPIORSKI, SAVELA 2011).

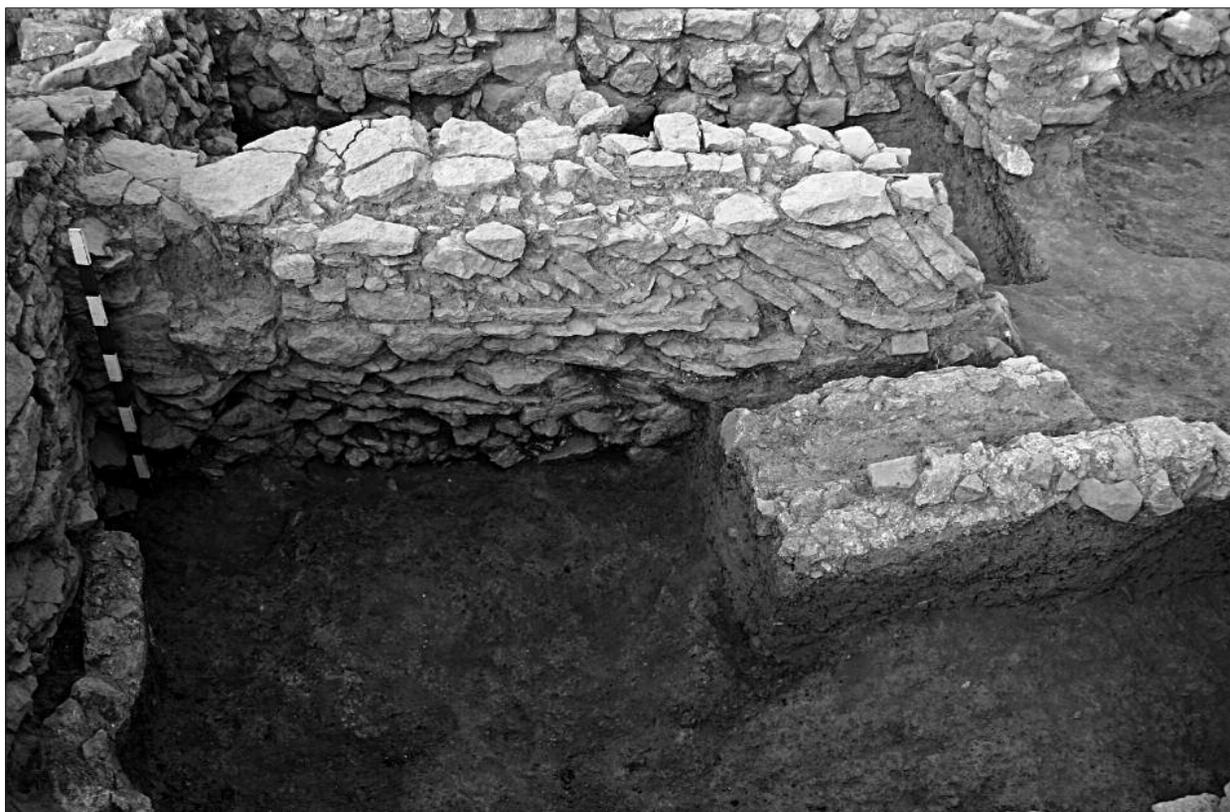
Fig. 3. Examinations in the interior of the barracks (view from the east). Fragment of the canal (water conduit?) and the reservoir situated below the foundations of the barracks. Cf. Fig. 1:6,7 (Photo A. Trzop-Szczypiorska).

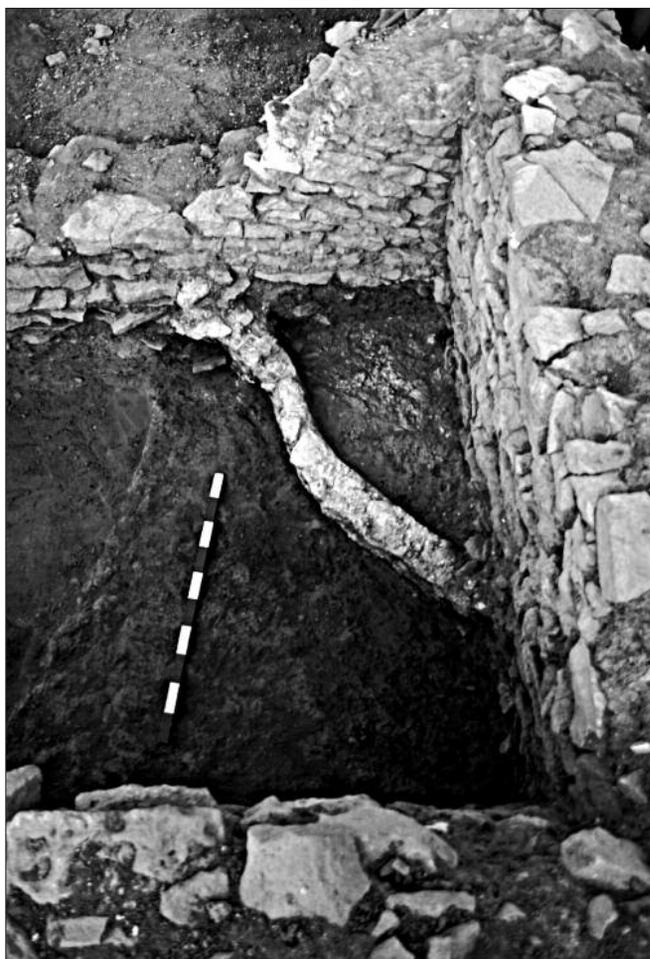
Fig. 4. Examinations in the interior of the barracks (view from the east). Fragment of the reservoir situated below the foundations of the barracks. Cf. Fig. 1:6 (Photo A. Trzop-Szczypiorska).

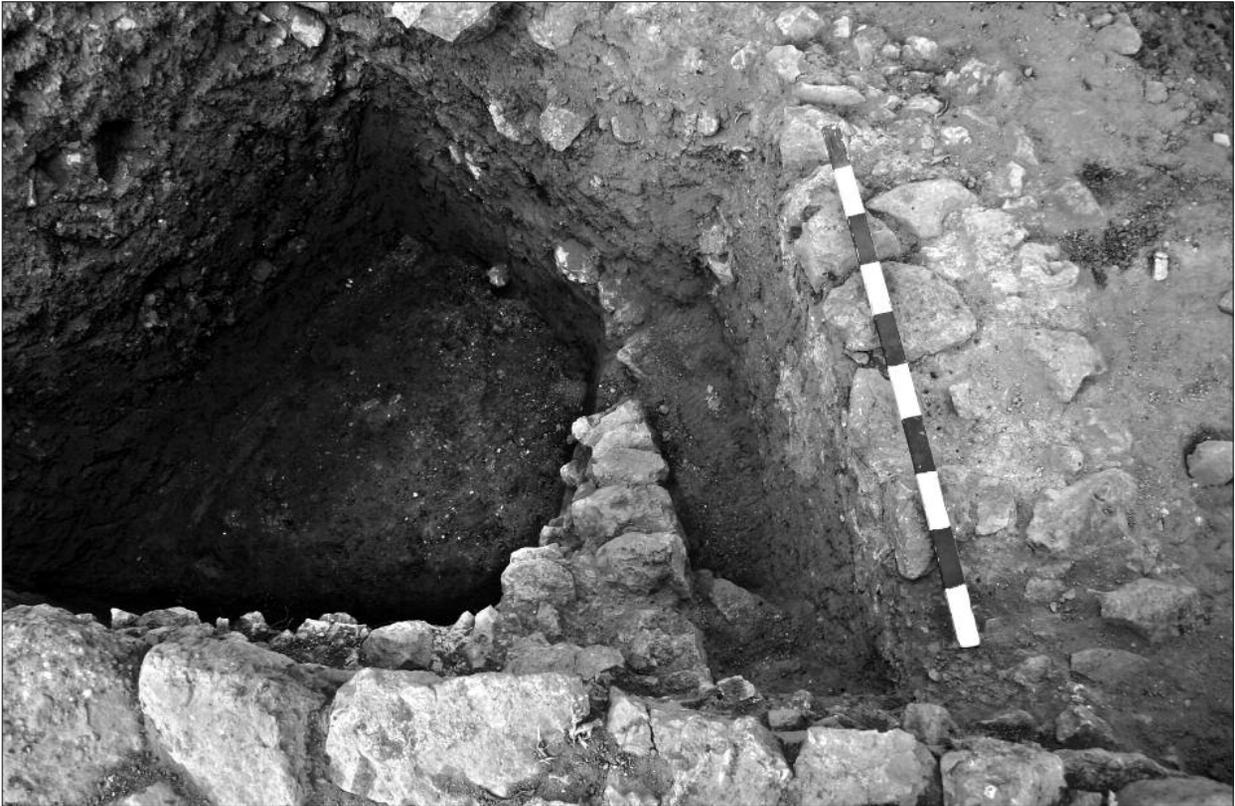
Fig. 5. Sewage canal in the street to the west of the barracks (view from the east). Canal comes out from under the western wall of the building and is cut with a Modern period pit. Cf. Fig. 1:4 (Photo A. Trzop-Szczypiorska).

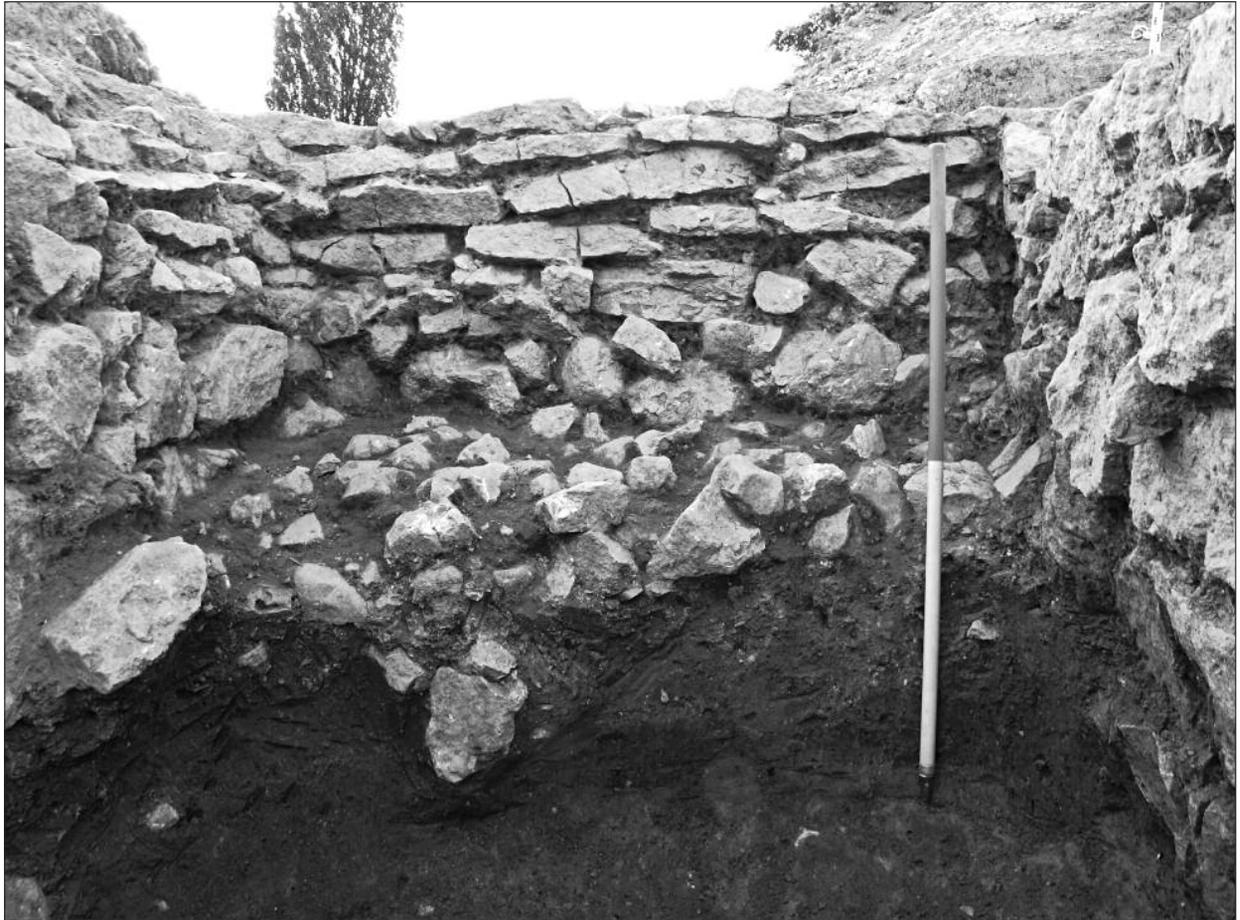
Fig. 6. One of the western rooms of the barracks in the course of excavations (view from the south). Remains of the pavement which adjoins the eastern wall can be seen in the room (Photo A. Trzop-Szczypiorska).
