MARTIN LEMKE

## FIELDWORK AT NOVAE (BULGARIA) IN 2009 AND 2010 (PLS. 199–201)

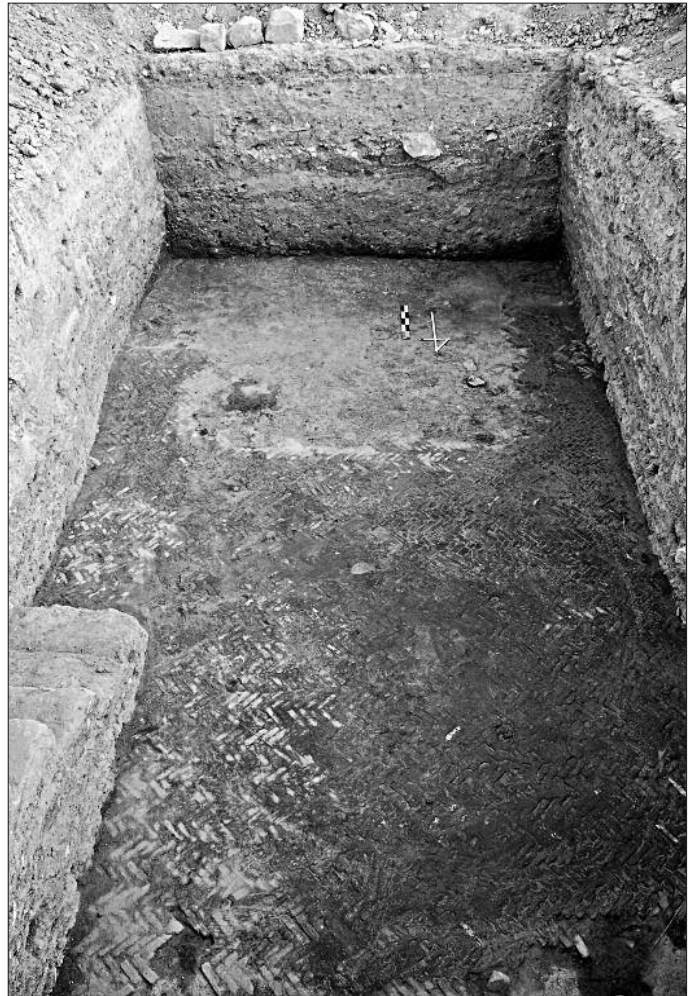
Fig. 1. Novae 2009. Basin with *opus spicatum* floor (Photo J. Reclaw).

Ryc. 1. Novae 2009. Basen z podłogą wyłożoną *opus spicatum*.

The entrance to the *basilica thermarum* was located on the eastern side of the building and approached from the *via praetoria*. The entrance was flanked by two short walls and provided with a high threshold to avoid flooding by rainwater. The adjacent room was adorned with wall painting. The construction with an *opus spicatum* floor (Fig. 1) first discovered in 2008 was identified to be a basin measuring 16×9 m. The floor consisted of small bricks laid on hydraulic mortar. Traces of calcite suggest that the floor was exposed to water over a long time. On the southern side, a wall limiting the floor was found, along with an aqueduct. One of the clay tubes bore a *planta pedis* stamp, stating the producer's name ARRIVS (Fig. 2). Obviously, the *opus spicatum* was the adorned floor of a *natatio* basin lying in the northern part of the *palestra*.

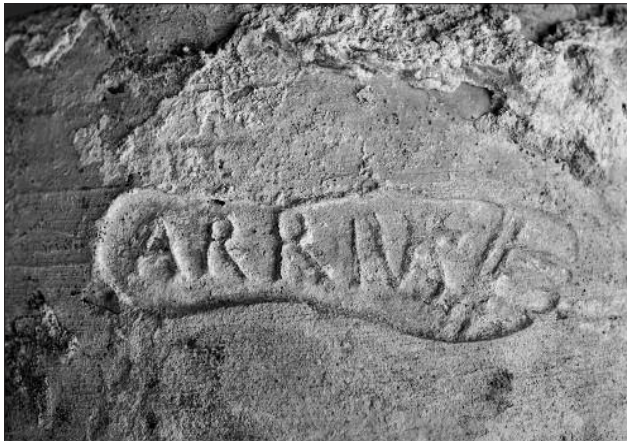
Fig. 2. Novae 2009. Potter's stamp *in planta pedis* on a terra cotta water pipe (Photo M. Bogacki).

Ryc. 2. Novae 2009. Stempel producenta *in planta pedis* na terakotowej rurze.

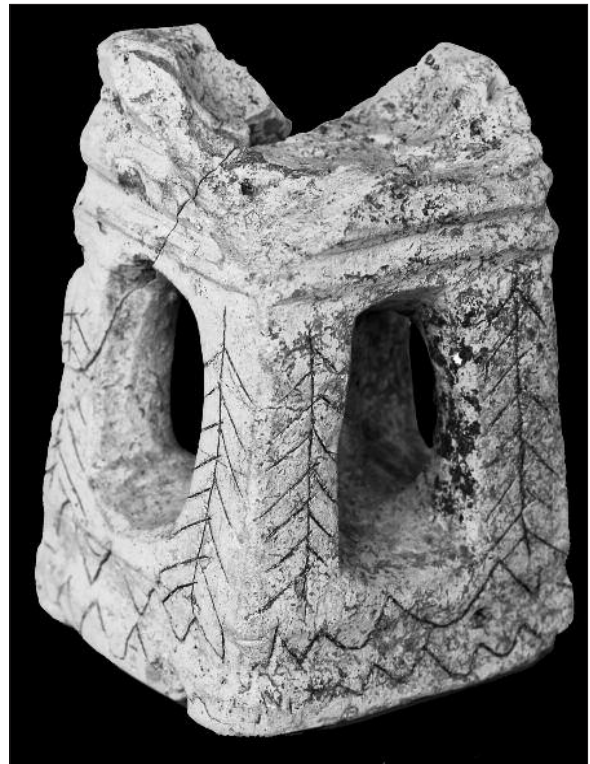
Fig. 3. Novae 2009. Clay altar (Photo J. Reclaw).

the course of some sewage channels changed. During the excavations a number of significant finds was unearthed, among them a series of early 1<sup>st</sup> c. coins (Augustus, Tiberius, Claudius), retrieved from the destruction layer after the earthquake, pottery including *terra sigillata* and glass vessels from the *thermae*. From the hospital level, an interestingly shaped clay altar (Fig. 3) and a bone sheath pommel are noteworthy.

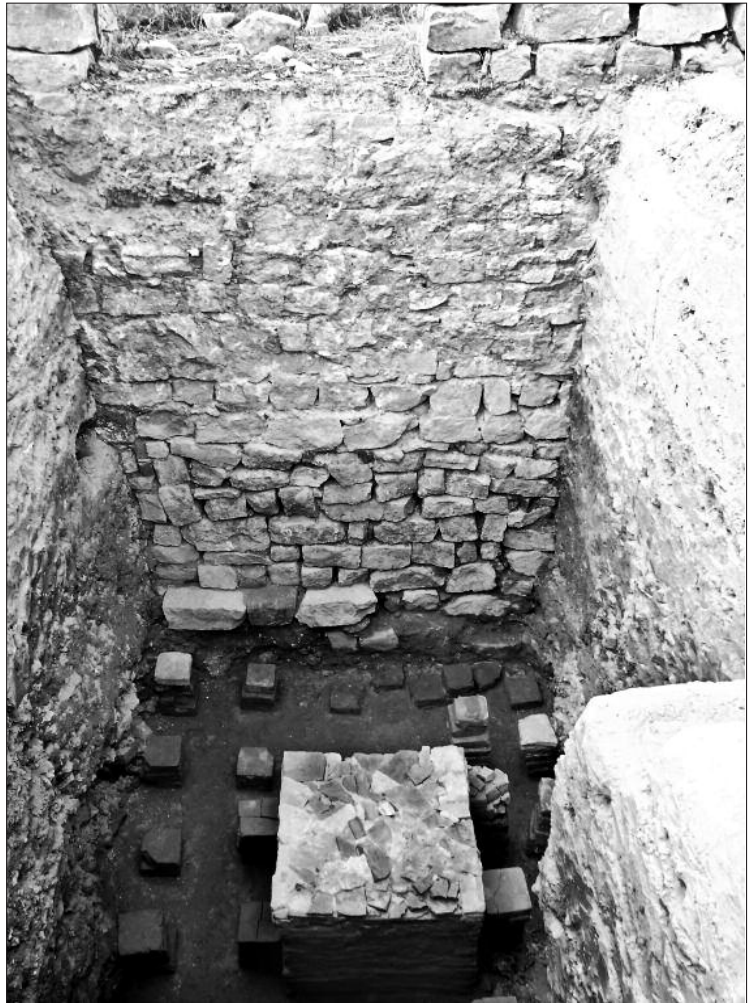
Fig. 5. Novae 2010. Hypocaust with a structural pedestal (Photo J. Reclaw).

Ryc. 5. Novae 2010. Hypocaustum z ceglanym podestem.

Interesting features were discovered within the *caldarium* of the baths. Here, three basins for hot water were located: two in apses facing west and heated by a common, big *praefurnium* and a rectangular one, heated separately. To acquire a maximally large heated space, the architects had devised a single room with a surface of more than 400 m<sup>2</sup>. Such measurements required the use of structural pillars for the roof – not an easy task considering the suspended floor of the *caldarium*. Therefore, square brick pedestals (0,9×0,9 m) were erected on stone foundations among the *suspensura* (Fig. 5). On them, pillars (probably made of bricks) were set. The reconstructed diameter of

these pillars measured slightly above 30 cm, just as the columns in the *palestra*. The *suspensurae* were made solidly of standardised *bessales*. The height of the cellar was c. 1 m. Within the walls of the *tepidarium* and *caldarium*, various *tubulatio* heating systems were used.

hypokaustyczny pod całym *caldarium*. Na kamiennym fundamencie znajdującym się poniżej podłogi piwnicy hypokaustycznej, wzniesiono z cegieł kwadratowe postumenty (Ryc. 5). Na nich ustawiono kolumny. W skrzydle zachodnim zlokalizowano prawdopodobnie pomieszczenia recepcyjne. Do łaźni prowadziło szereg wodociągów z rur ceramicznych, które niekiedy nosiły stemple producenta (Ryc. 2). Jedne zaopatrywały basen *natatio*, inne – basenowe *frigidarium* i *caldarium*. Wielkie ilości wody wpływające do łaźni były odprowadzane siecią kanałów (Ryc. 6). Odkryte pozostałości architektoniczne sugerują częściowe zniszczenie łaźni przez trzęsienie ziemi i jej późniejszą odbudowę. Podczas kampanii w 2009 i 2010 roku odsłonięto także kolejne pozostałości po budowlach związanych z pobytem w Novae, od 45 r. n.e., legionu *VIII Augusta*.

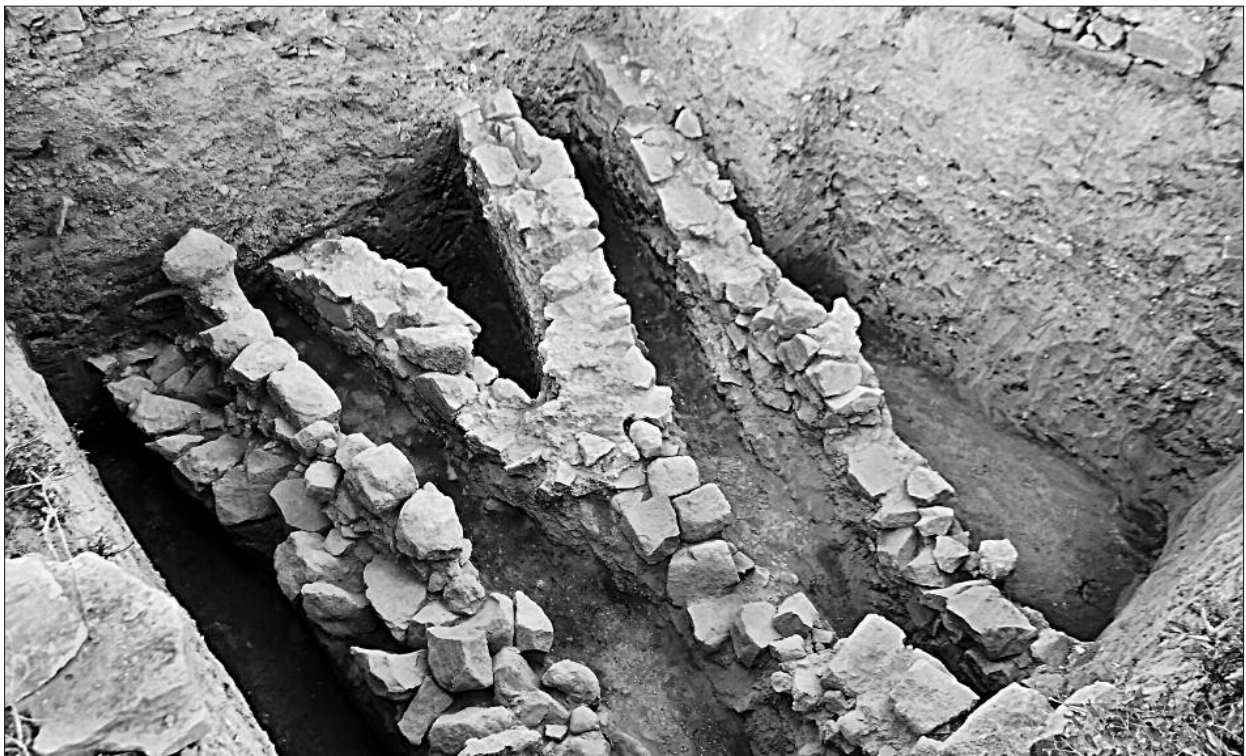
Fig. 6. Novae 2010. Sewage channels (Photo J. Reclaw).

Ryc. 6. Novae 2010. Kanały odpływowe.

A number of clay pipe aqueducts ran up to the *thermae*. One filled the *natatio*, others the basins of the *frigidarium* and *caldarium*. The enormous amount of water<sup>7</sup> required by the *thermae* was disposed of by a complex sewage network (Fig. 6). A total of six channels were found, made of stone and mortar. The sewers ran below the western part of the building, as a result of the general layout as well as terrain properties. After the earthquake, the channels were not fixed, but instead equipped with bypasses to avoid the leaking parts.
